Manhole Inspection Report

Date:	04/27/2018	Weather:		Coding:	RZMACP
MH#:	M-706-010.1	Owner:	NA	Len. Surveyed:	8.2
P.O.#:		Surveyor:	Jen Costello	Rim to Invert:	8.2
Customer:		Cert. #:	U-907-5518	Wall Material:	Concrete (reinforced)

Street:	State St. 223' South of 8th St.	Project:	Hobart, IN
City:	Hobart, IN	GPS Northing:	41.52482224
Location:		GPS Easting:	-87.25336456
Drain Area:	Southeast	GPS Accuracy:	Nearest Meter
Cover Shape:	Circular	Evidence of Surcharge:	No
Cover Size:	22.5	Potential for Runoff:	None
Comments:

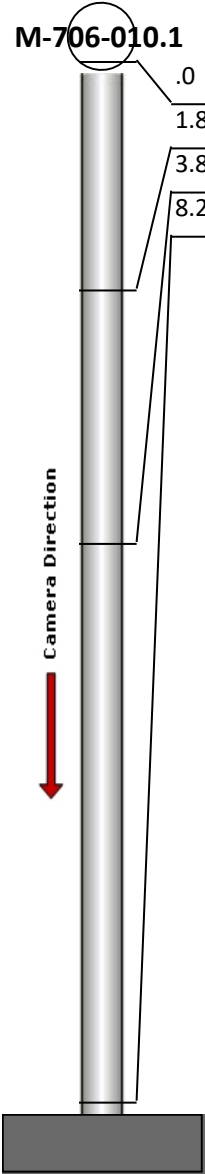
.0	MGO	General Observation	10	NA
	1.8	MGP	General Photo	27	NA
	3.8	FM	Fracture Multiple	44	S 4
	8.2	MGO	General Observation	65	NA
