Manhole Inspection Report

Date:	04/24/2018	Weather:		Coding:	RZMACP
MH#:	M-706-010.3	Owner:	NA	Len. Surveyed:	8.6
P.O.#:		Surveyor:	Jen Costello	Rim to Invert:	8.1
Customer:	8.7	Cert. #:	U-907-5518	Wall Material:	Concrete (reinforced)

Street:	Intersection of State St. and 9th St.	Project:	Hobart, IN
City:	Hobart, IN	GPS Northing:	0.0
Location:		GPS Easting:	0.0
Drain Area:	Southeast	GPS Accuracy:	Nearest Meter
Cover Shape:	Circular	Evidence of Surcharge:	No
Cover Size:	22.5	Potential for Runoff:	None
Comments:

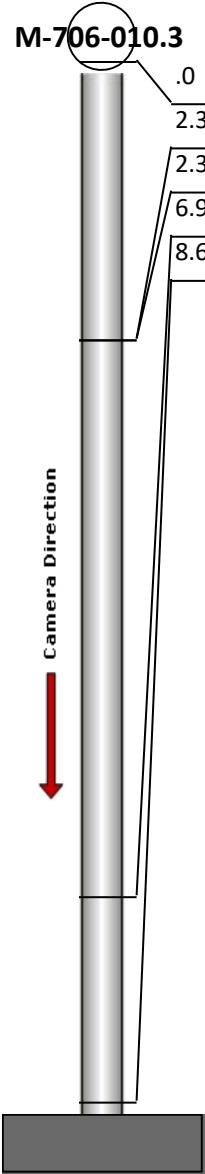
.0	MGO	General Observation	10	NA
	2.3	MGP	General Photo	28	NA
	2.3	SRI	Surface Roughness Increased	38	S 1
	6.9	OBR	Obstacle Rocks	61	M 2
	8.6	MGO	General Observation	76	NA
