Manhole Inspection Report

Date:	04/24/2018	Weather:		Coding:	RZMACP
MH#:	M-706-010.6	Owner:	NA	Len. Surveyed:	8.8
P.O.#:		Surveyor:	John Kuglmaier	Rim to Invert:	8.6
Customer:	8.7	Cert. #:	U-1215-07002349	Wall Material:	Concrete (reinforced)

Street:	Intersection of State St. and 10th St.	Project:	Hobart, IN
City:	Hobart, IN	GPS Northing:	0.0
Location:		GPS Easting:	0.0
Drain Area:	Southeast	GPS Accuracy:	Nearest Meter
Cover Shape:	Circular	Evidence of Surcharge:	No
Cover Size:	22.5	Potential for Runoff:	None
Comments:

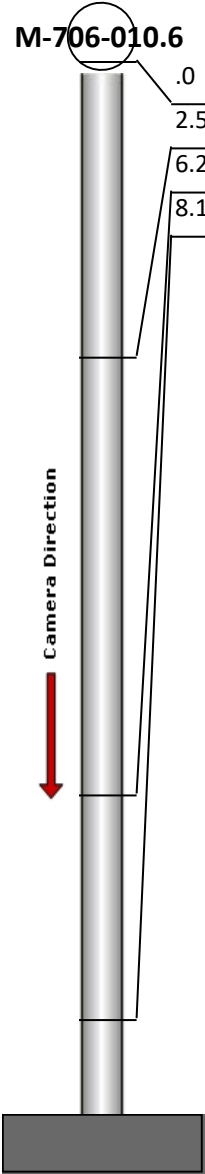
.0	MGP	General Photo	10	NA
	2.5	MGP	General Photo	29	NA
	6.2	DSF	Deposits Settled Fine	50	M 2
	8.1	MGO	General Observation	65	NA
