Manhole Inspection Report

Date:	04/23/2018	Weather:		Coding:	RZMACP
MH#:	M-706-013.5	Owner:	NA	Len. Surveyed:	8.5
P.O.#:		Surveyor:	Jen Costello	Rim to Invert:	8.6
Customer:	8.7	Cert. #:	U-907-5518	Wall Material:	Concrete (reinforced)

Street:	Water St. 211' North of 10th St.	Project:	Hobart, IN
City:	Hobart, IN	GPS Northing:	0.0
Location:		GPS Easting:	0.0
Drain Area:	Southeast	GPS Accuracy:	Nearest Meter
Cover Shape:	Circular	Evidence of Surcharge:	No
Cover Size:	22.5	Potential for Runoff:	None
Comments:

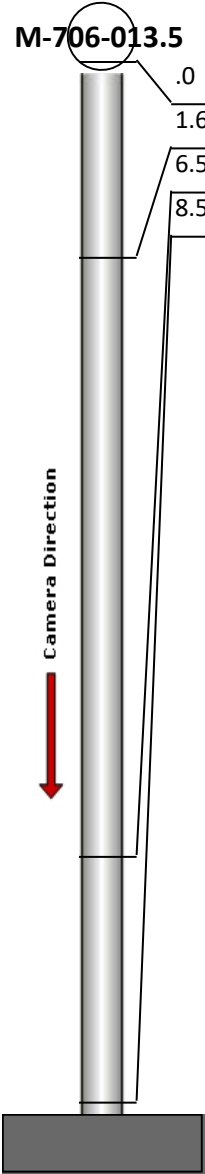
Position	Code	Observation	Video (sec)	Grade
M-706-013.5

.0	MGO	General Observation	10	NA
	1.6	MGO	General Observation	27	NA
	6.5	IW	Infil Weeper	50	M 2
	8.5	MGO	General Observation	65	NA
