# Manhole Inspection Report

| MH#: | <b>M-706-020</b> | Owner: | <b>NA</b> | Len. Surveyed: | <b>8.7</b> |

| Street: | <b>On Main St. 140' North of 7th St.</b> | Project: | <b>Hobart, IN</b> |

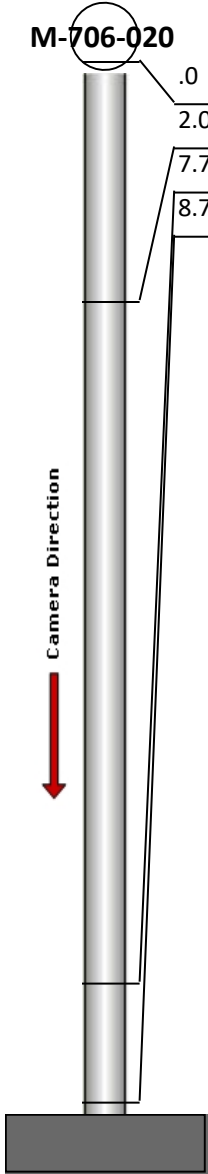
| | Position | Code | Observation | Video (sec) | Grade |
|--|---|---|---|---|---|
| | M-706-020 | | | | |

| | Position | Code | Observation | Video (sec) | Grade |
|--|---|---|---|---|---|
| | 7.7 | OBB | Obstacle Brick | 52 | M 2 |
