Manhole Inspection Report

Date:	04/28/2018	Weather:		Coding:	RZMACP
MH#:	M-706-022	Owner:	NA	Len. Surveyed:	6.3
P.O.#:		Surveyor:	Jen Costello	Rim to Invert:	6.3
Customer:		Cert. #:	U-907-5518	Wall Material:	Brick

Street:	Hwy 51. 215' South of 7th St.	Project:	Hobart, IN
City:	Hobart, IN	GPS Northing:	41.52661133
Location:		GPS Easting:	-87.25228119
Drain Area:	South	GPS Accuracy:	Nearest Meter
Cover Shape:	Circular	Evidence of Surcharge:	No
Cover Size:	22.5	Potential for Runoff:	None
Comments:

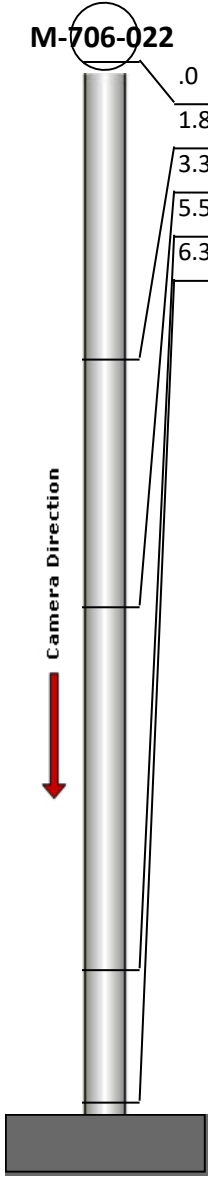
.0	MGO	General Observation	10	NA
	1.8	MGO	General Observation	27	NA
	3.3	MMC	Material Change	43	NA
	5.5	DSF	Deposits Settled Fine	58	M 2
	6.3	MGO	General Observation	70	NA
