Manhole Inspection Report

Date:	04/24/2018	Weather:		Coding:	RZMACP
MH#:	M-706-028	Owner:	NA	Len. Surveyed:	17.5
P.O.#:		Surveyor:	John Kuglmaier	Rim to Invert:	17.3
Customer:	8.7	Cert. #:	U-1215-07002349	Wall Material:	Concrete (reinforced)

Street:	Intersection of Linda St. and 10th St.	Project:	Hobart, IN
City:	Hobart, IN	GPS Northing:	0.0
Location:		GPS Easting:	0.0
Drain Area:	Southeast	GPS Accuracy:	Nearest Meter
Cover Shape:	Circular	Evidence of Surcharge:	Yes
Cover Size:	22.5	Potential for Runoff:	None
Comments:

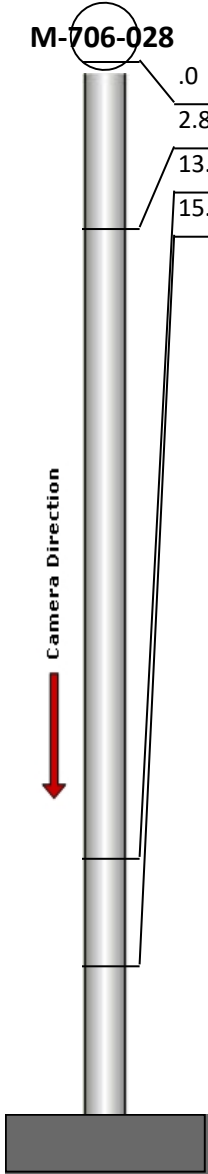
M-706-028				
	.0	MGP	General Photo	10	NA
	2.8	MGP	General Photo	29	NA
	13.4	DAZ	Deposits Attached Other	64	M 3
	15.2	MGO	General Observation	79	NA
