Manhole Inspection Report

Date:	04/27/2018	Weather:		Coding:	RZMACP
MH#:	M-706-030	Owner:	NA	Len. Surveyed:	6.7
P.O.#:		Surveyor:	Jen Costello	Rim to Invert:	7.0
Customer:		Cert. #:	U-907-5518	Wall Material:	Brick

Street:	Intersection of 7th St. and State St.	Project:	Hobart, IN
City:	Hobart, IN	GPS Northing:	41.5273819
Location:		GPS Easting:	-87.2536087
Drain Area:	South	GPS Accuracy:	Nearest Meter
Cover Shape:	Circular	Evidence of Surcharge:	No
Cover Size:	22.5	Potential for Runoff:	None
Comments:

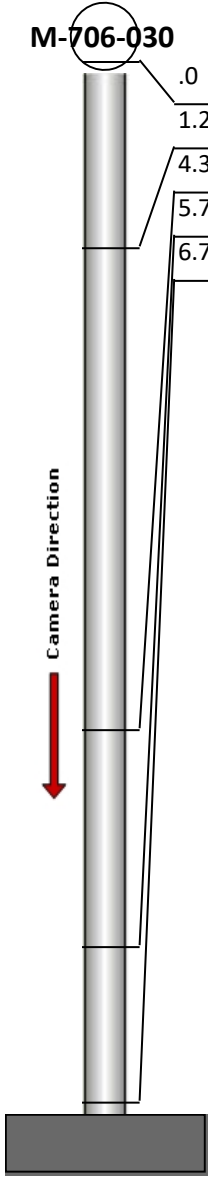
.0	MGO	General Observation	10	NA
	1.2	MGP	General Photo	26	NA
	4.3	OBZ	Obstacle Other	45	M 2
	5.7	DSF	Deposits Settled Fine	59	M 2
	6.7	MGO	General Observation	72	NA
