Manhole Inspection Report

Date:	04/27/2018	Weather:		Coding:	RZMACP
MH#:	M-706-037	Owner:	NA	Len. Surveyed:	8.6
P.O.#:		Surveyor:	Jen Costello	Rim to Invert:	7.5
Customer:		Cert. #:	U-907-5518	Wall Material:	Brick

Street:	Lake St. 333' South of 7th St.	Project:	Hobart, IN
City:	Hobart, IN	GPS Northing:	41.52632523
Location:		GPS Easting:	-87.25468445
Drain Area:	South	GPS Accuracy:	Nearest Meter
Cover Shape:	Circular	Evidence of Surcharge:	No
Cover Size:	22.5	Potential for Runoff:	None
Comments:

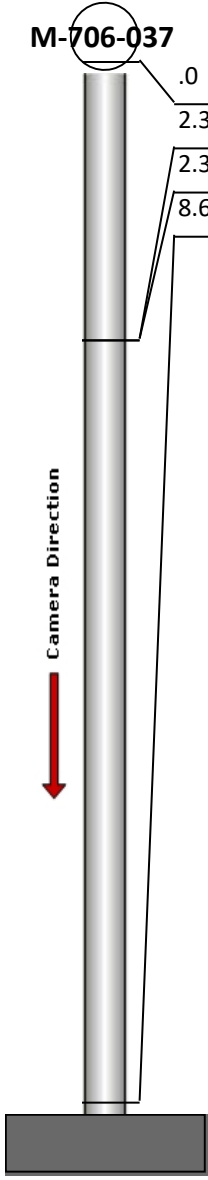
M-706-037				
	.0	MGO	General Observation	10	NA
	2.3	MMC	Material Change	26	NA
	2.3	MGO	General Observation	39	NA
	8.6	MGO	General Observation	65	NA
