Manhole Inspection Report

Date:	04/29/2018	Weather:		Coding:	RZMACP
MH#:	M-706-049	Owner:	NA	Len. Surveyed:	6.5
P.O.#:		Surveyor:	Jen Costello	Rim to Invert:	6.3
Customer:		Cert. #:	U-907-5518	Wall Material:	Concrete (reinforced)

Street:	On Garfield St. 250' North of 8th St.	Project:	Hobart, IN
City:	Hobart, IN	GPS Northing:	41.52609634
Location:		GPS Easting:	-87.25106812
Drain Area:	South	GPS Accuracy:	Nearest Meter
Cover Shape:	Circular	Evidence of Surcharge:	No
Cover Size:	22.5	Potential for Runoff:	None
Comments:

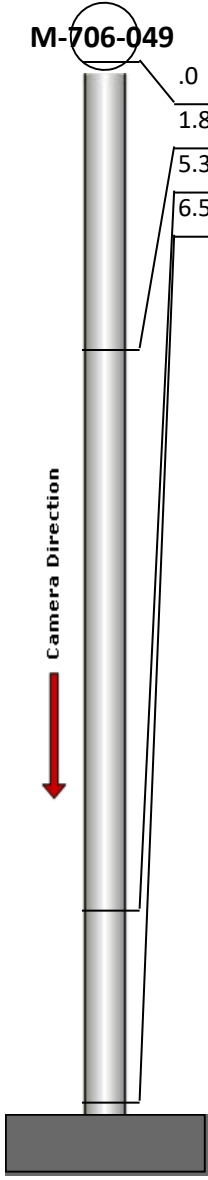
.0	MGO	General Observation	10	NA
	1.8	MGP	General Photo	27	NA
	5.3	DSF	Deposits Settled Fine	47	M 2
	6.5	MGO	General Observation	61	NA
