Manhole Inspection Report

Date:	04/26/2018	Weather:		Coding:	RZMACP
MH#:	M-706-063	Owner:	NA	Len. Surveyed:	8.3
P.O.#:		Surveyor:	Jen Costello	Rim to Invert:	8.0
Customer:		Cert. #:	U-907-5518	Wall Material:	Concrete (reinforced)

Street:	On Lake Park Ave. 71' South of Debb	Project:	Hobart, IN
City:	Hobart, IN	GPS Northing:	2904546.05
Location:		GPS Easting:	2904546.05
Drain Area:	Southeast	GPS Accuracy:	Sub-Meter
Cover Shape:	Circular	Evidence of Surcharge:	No
Cover Size:	22.5	Potential for Runoff:	None
Comments:

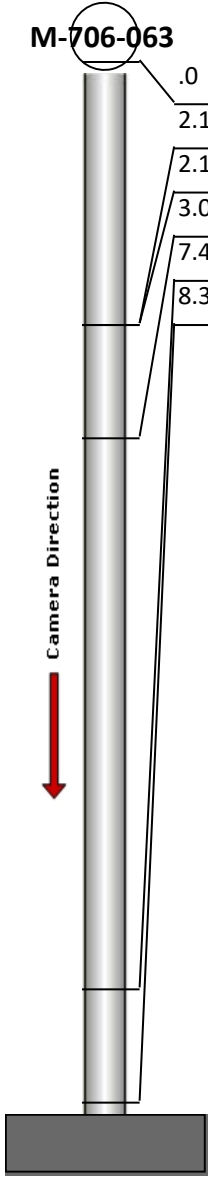
.0	MGO	General Observation	10	NA
	2.1	MGO	General Observation	28	NA
	2.1	IS	Infil Stain	41	NA
	3.0	B	Broken	56	S 4
	7.4	DSF	Deposits Settled Fine	78	M 2
	8.3	MGO	General Observation	92	NA
