Manhole Inspection Report

Date:	04/24/2018	Weather:		Coding:	RZMACP
MH#:	M-706-069	Owner:	NA	Len. Surveyed:	8.3
P.O.#:		Surveyor:	John Kuglmaier	Rim to Invert:	7.8
Customer:	8.7	Cert. #:	U-1215-07002349	Wall Material:	Concrete (reinforced)

Street:	On Linda St. 87' North of 10th St.	Project:	Hobart, IN
City:	Hobart, IN	GPS Northing:	0.0
Location:		GPS Easting:	0.0
Drain Area:	Southeast	GPS Accuracy:	Nearest Meter
Cover Shape:	Circular	Evidence of Surcharge:	No
Cover Size:	22.5	Potential for Runoff:	None
Comments:

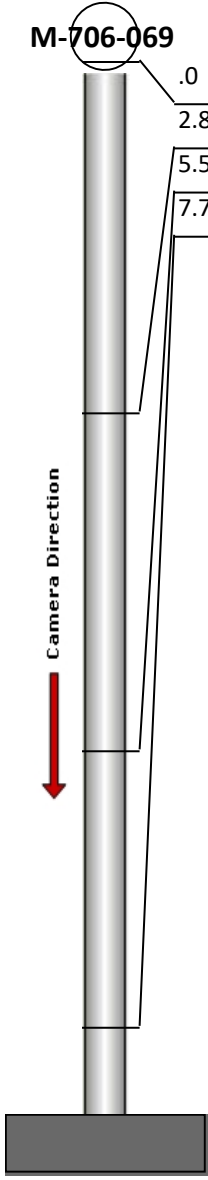
.0	MGP	General Photo	10	NA
	2.8	MGP	General Photo	30	NA
	5.5	DAZ	Deposits Attached Other	49	M 3
	7.7	MGO	General Observation	65	NA
