Manhole Inspection Report

Date:	04/18/2018	Weather:		Coding:	RZMACP
MH#:	M-707-006	Owner:	NA	Len. Surveyed:	11.7
P.O.#:		Surveyor:	John Kuglmaier	Rim to Invert:	12.0
Customer:		Cert. #:	U-1215-07002349	Wall Material:	Concrete (reinforced)

Street:	Intersection of Garfield St. and 13th	Project:	Hobart, IN
City:	Hobart, IN	GPS Northing:	0.0
Location:		GPS Easting:	0.0
Drain Area:	Southeast	GPS Accuracy:	Nearest Meter
Cover Shape:	Circular	Evidence of Surcharge:	No
Cover Size:	22.5	Potential for Runoff:	None
Comments:

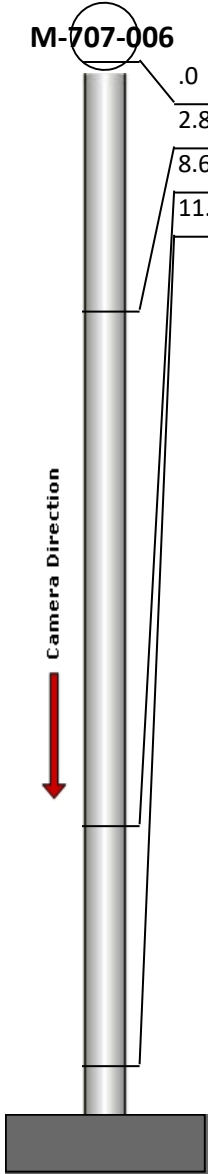
.0	MGP	General Photo	10	NA
	2.8	MGP	General Photo	29	NA
	8.6	DSF	Deposits Settled Fine	55	M 2
	11.3	MGO	General Observation	71	NA
