Manhole Inspection Report

Date:	04/16/2018	Weather:		Coding:	RZMACP
MH#:	M-707-042	Owner:	NA	Len. Surveyed:	4.8
P.O.#:		Surveyor:	John Kuglmaier	Rim to Invert:	5.0
Customer:		Cert. #:	U-1215-07002349	Wall Material:	Concrete (reinforced)

Street:	13th St. 157' West of Maple St.	Project:	Hobart, IN
City:	Hobart, IN	GPS Northing:	2905810.574
Location:		GPS Easting:	2905810.574
Drain Area:	Southeast	GPS Accuracy:	Sub-Meter
Cover Shape:	Circular	Evidence of Surcharge:	Yes
Cover Size:	29.0	Potential for Runoff:	None
Comments:

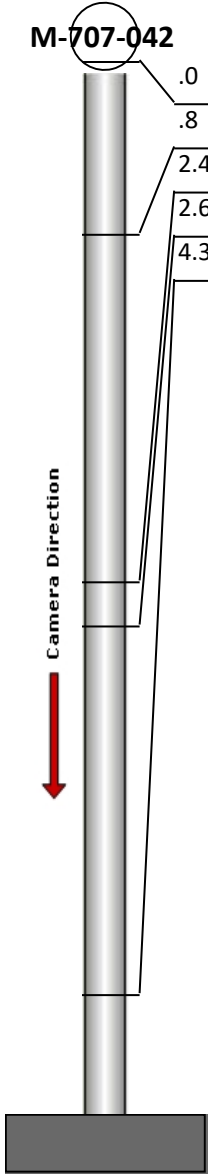
.0	MGP	General Photo	10	NA
	.8	DB	Displaced Brick	23	S 3
	2.4	DAZ	Deposits Attached Other	38	M 2
	2.6	MGP	General Photo	52	NA
	4.3	MGO	General Observation	69	NA
