# Manhole Inspection Report

| MH#: | <b>M-707-048</b> | Owner: | <b>NA</b> | Len. Surveyed: | <b>7.3</b> |

| Street: | <b>13th Pl. 259' West of Flemming St.</b> | Project: | <b>Hobart, IN</b> |

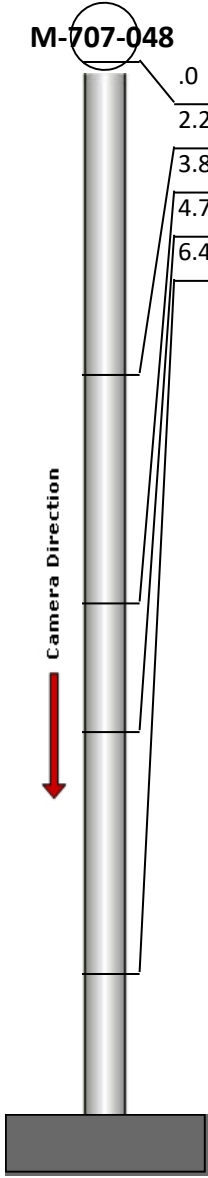
| | Position | Code | Observation | Video (sec) | Grade |
|--|---|---|---|---|---|
| | .0 | MGP | General Photo | 10 | NA |
| | 2.2 | MGP | General Photo | 28 | NA |
| | 3.8 | IS | Infil Stain | 45 | NA |
| | 4.7 | DAZ | Deposits Attached Other | 59 | M 3 |
| | 6.4 | MGO | General Observation | 74 | NA |
