Manhole Inspection Report

Date:	04/06/2018	Weather:		Coding:	RZMACP
MH#:	M-707-053	Owner:	NA	Len. Surveyed:	12.0
P.O.#:		Surveyor:	John Kuglmaier	Rim to Invert:	12.1
Customer:		Cert. #:	U-1215-07002349	Wall Material:	Concrete (reinforced)

Street:	Intersection of 13th St. and Lake Par	Project:	Hobart, IN
City:	Hobart, IN	GPS Northing:	0.0
Location:		GPS Easting:	0.0
Drain Area:	Southwest	GPS Accuracy:	Nearest Meter
Cover Shape:	Circular	Evidence of Surcharge:	No
Cover Size:	22.5	Potential for Runoff:	None
Comments:

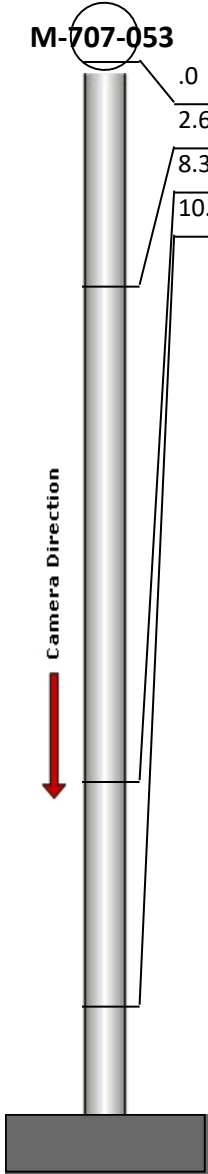
.0	MGP	General Photo	10	NA
	2.6	MGP	General Photo	29	NA
	8.3	DAZ	Deposits Attached Other	54	M 2
	10.9	MGO	General Observation	71	NA
