Manhole Inspection Report

Date:	04/17/2018	Weather:		Coding:	RZMACP
MH#:	M-707-054	Owner:	NA	Len. Surveyed:	6.7
P.O.#:		Surveyor:	John Kuglmaier	Rim to Invert:	7.1
Customer:		Cert. #:	U-1215-07002349	Wall Material:	Concrete (reinforced)

Street:	13th St. 270' West of Flemming St.	Project:	Hobart, IN
City:	Hobart, IN	GPS Northing:	2905070.601
Location:		GPS Easting:	2905070.601
Drain Area:	Southwest	GPS Accuracy:	Sub-Meter
Cover Shape:	Circular	Evidence of Surcharge:	No
Cover Size:	22.5	Potential for Runoff:	None
Comments:

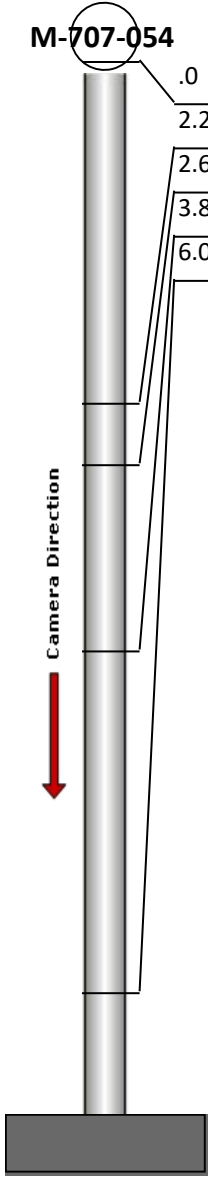
.0	MGP	General Photo	10	NA
	2.2	IS	Infil Stain	26	NA
	2.6	MGP	General Photo	41	NA
	3.8	DSGV	Deposits Settled Gravel	57	M 2
	6.0	MGO	General Observation	73	NA
