Manhole Inspection Report

Date:	04/17/2018	Weather:		Coding:	RZMACP
MH#:	M-707-055	Owner:	NA	Len. Surveyed:	8.4
P.O.#:		Surveyor:	John Kuglmaier	Rim to Invert:	6.6
Customer:		Cert. #:	U-1215-07002349	Wall Material:	Concrete (reinforced)

Street:	Intersection of 13th St. and Flemmin	Project:	Hobart, IN
City:	Hobart, IN	GPS Northing:	2905341.261
Location:		GPS Easting:	2905341.261
Drain Area:	Southwest	GPS Accuracy:	Sub-Meter
Cover Shape:	Circular	Evidence of Surcharge:	No
Cover Size:	22.5	Potential for Runoff:	None
Comments:

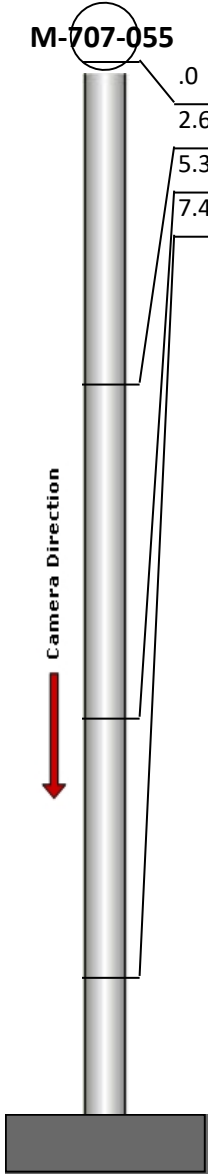
.0	MGP	General Photo	10	NA
	2.6	MGP	General Photo	29	NA
	5.3	DSF	Deposits Settled Fine	48	M 2
	7.4	MGO	General Observation	64	NA
