Manhole Inspection Report

Date:	04/23/2018	Weather:		Coding:	RZMACP
MH#:	M-707-068	Owner:	NA	Len. Surveyed:	4.9
P.O.#:		Surveyor:	Jen Costello	Rim to Invert:	4.6
Customer:	8.7	Cert. #:	U-907-5518	Wall Material:	Brick

Street:	Intersection of Lake St. and 10th St.	Project:	Hobart, IN
City:	Hobart, IN	GPS Northing:	0.0
Location:		GPS Easting:	0.0
Drain Area:	Southeast	GPS Accuracy:	Nearest Meter
Cover Shape:	Circular	Evidence of Surcharge:	No
Cover Size:	22.5	Potential for Runoff:	None
Comments:

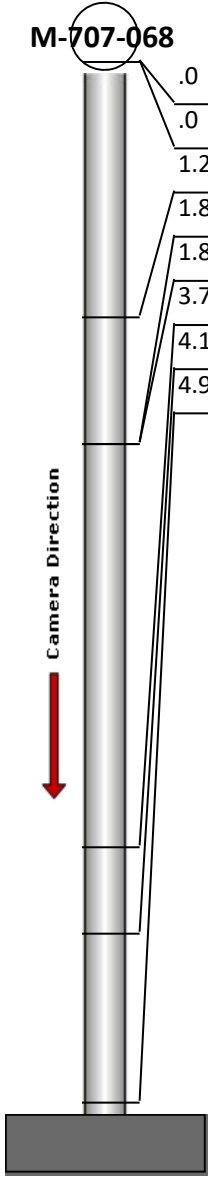
.0	MGO	General Observation	10	NA
	1.0	DB	Displaced Brick	20	S 3
	1.2	SAV	Surface Aggregate Visible	33	S 3
	1.8	MGO	General Observation	47	NA
	1.8	FL	Fracture Longitudinal	59	S 3
	3.7	SAP	Surface Aggregate Projecting	75	S 3
	4.1	OBR	Obstacle Rocks	87	M 2
	4.9	MGO	General Observation	101	NA
