# Manhole Inspection Report

Date:	04/23/2018	Weather:		Coding:	RZMACP
MH#:	M-707-069	Owner:	NA	Len. Surveyed:	4.7
P.O.#:		Surveyor:	John Kuglmaier	Rim to Invert:	4.4
Customer:	8.7	Cert. #:	U-1215-07002349	Wall Material:	Concrete (reinforced)

Street:	Intersection of 10th St. and Water St	Project:	Hobart, IN
City:	Hobart, IN	GPS Northing:	0.0
Location:		GPS Easting:	0.0
Drain Area:	Southeast	GPS Accuracy:	Nearest Meter
Cover Shape:	Circular	Evidence of Surcharge:	No
Cover Size:	22.5	Potential for Runoff:	None
Comments:

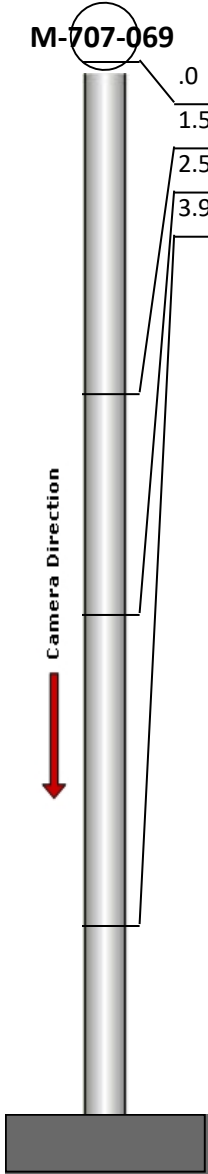
.0	MGP	General Photo	10	NA
	1.5	DAZ	Deposits Attached Other	24	M 3
	2.5	MGP	General Photo	40	NA
	3.9	MGO	General Observation	56	NA
