Manhole Inspection Report

Date:	04/16/2018	Weather:		Coding:	RZMACP
MH#:	M-707-070	Owner:	NA	Len. Surveyed:	10.4
P.O.#:		Surveyor:	John Kuglmaier	Rim to Invert:	10.9
Customer:		Cert. #:	U-1215-07002349	Wall Material:	Concrete (reinforced)

Street:	13th Pl. 159' East of Lake Park Ave.	Project:	Hobart, IN
City:	Hobart, IN	GPS Northing:	2904811.364
Location:		GPS Easting:	2904811.364
Drain Area:	Southwest	GPS Accuracy:	Sub-Meter
Cover Shape:	Circular	Evidence of Surcharge:	No
Cover Size:	29.0	Potential for Runoff:	None
Comments:

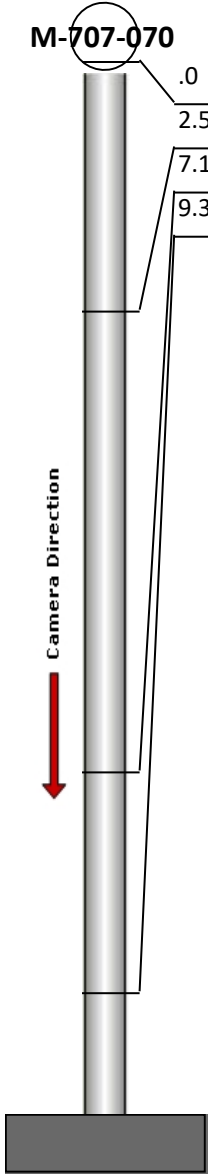
Position	Code	Observation	Video (sec)	Grade

.0	MGP	General Photo	10	NA
	2.5	MGP	General Photo	29	NA
	7.1	DAZ	Deposits Attached Other	52	M 2
	9.3	MGO	General Observation	67	NA
