Manhole Inspection Report

Date:	04/17/2018	Weather:		Coding:	RZMACP
MH#:	M-707-073	Owner:	NA	Len. Surveyed:	3.1
P.O.#:		Surveyor:	John Kuglmaier	Rim to Invert:	3.4
Customer:		Cert. #:	U-1215-07002349	Wall Material:	Concrete (reinforced)

Street:	181' South of 11th St. 183' North of	Project:	Hobart, IN
City:	Hobart, IN	GPS Northing:	2905388.695
Location:		GPS Easting:	2905388.695
Drain Area:	Southeast	GPS Accuracy:	Sub-Meter
Cover Shape:	Circular	Evidence of Surcharge:	No
Cover Size:	22.5	Potential for Runoff:	None
Comments:

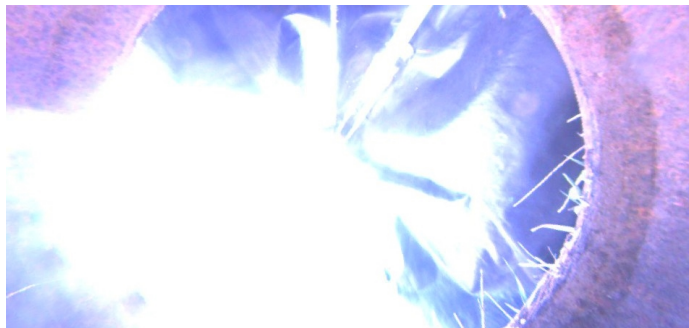
Code: **MGP**
Description: **General Photo**

Distance (ft): **1.4**
Structural Grade: **0**
O&M Grade: **0**
Clock Start/From:
Clock To:
1st Value:
2nd Value:
Value Percent:
Step: **NO**
Remarks:
