Manhole Inspection Report

Date:	04/17/2018	Weather:		Coding:	RZMACP
MH#:	M-707-076	Owner:	NA	Len. Surveyed:	6.0
P.O.#:		Surveyor:	Jen Costello	Rim to Invert:	6.5
Customer:		Cert. #:	U-907-5518	Wall Material:	Concrete (reinforced)

Street:	State St. 250' South of 13th St.	Project:	Hobart, IN
City:	Hobart, IN	GPS Northing:	2906227.6
Location:		GPS Easting:	2906227.6
Drain Area:	Southeast	GPS Accuracy:	Sub-Meter
Cover Shape:	Circular	Evidence of Surcharge:	No
Cover Size:	22.5	Potential for Runoff:	None
Comments:

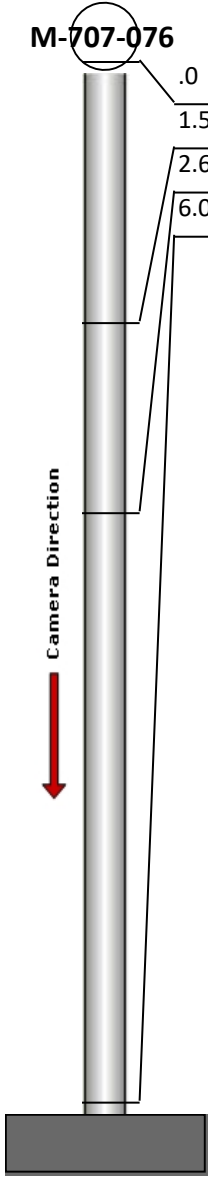
.0	MGO	General Observation	10	NA
	1.5	MGO	General Observation	26	NA
	2.6	IW	Infil Weeper	41	M 2
	6.0	MGO	General Observation	59	NA
