Manhole Inspection Report

Date:	04/18/2018	Weather:		Coding:	RZMACP
MH#:	M-708-008	Owner:	NA	Len. Surveyed:	4.6
P.O.#:		Surveyor:	John Kuglmaier	Rim to Invert:	4.6
Customer:		Cert. #:	U-1215-07002349	Wall Material:	Concrete (reinforced)

Street:	State St. 240' South of 14th St.	Project:	Hobart, IN
City:	Hobart, IN	GPS Northing:	2906171.765
Location:		GPS Easting:	2906171.765
Drain Area:	Southeast	GPS Accuracy:	Sub-Meter
Cover Shape:	Circular	Evidence of Surcharge:	No
Cover Size:	22.5	Potential for Runoff:	None
Comments:

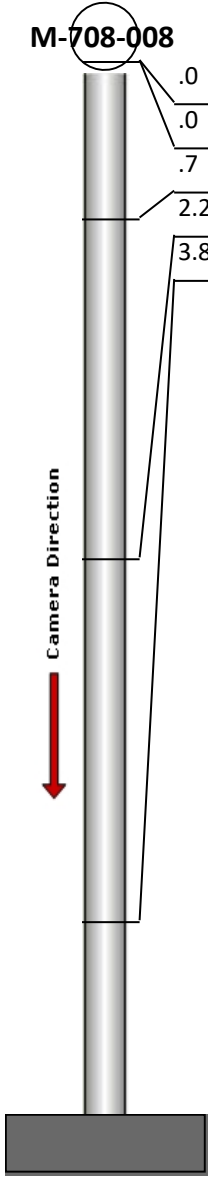
.0	MGP	General Photo	10	NA
	.0	MMM	Mortar Missing Medium	22	S 3
	.7	DAZ	Deposits Attached Other	35	M 2
	2.2	MGP	General Photo	52	NA
	3.8	MGO	General Observation	69	NA
