# Manhole Inspection Report

Date:	04/19/2018	Weather:		Coding:	RZMACP
MH#:	M-708-009	Owner:	NA	Len. Surveyed:	11.1
P.O.#:		Surveyor:	John Kuglmaier	Rim to Invert:	11.8
Customer:		Cert. #:	U-1215-07002349	Wall Material:	Concrete (reinforced)

Street:	Lake Park Ave. 61st Ave. to the East.	Project:	Hobart, IN
City:	Hobart, IN	GPS Northing:	2904705.666
Location:		GPS Easting:	2904705.666
Drain Area:	Southwest	GPS Accuracy:	Sub-Meter
Cover Shape:	Circular	Evidence of Surcharge:	Yes
Cover Size:	22.5	Potential for Runoff:	None
Comments:

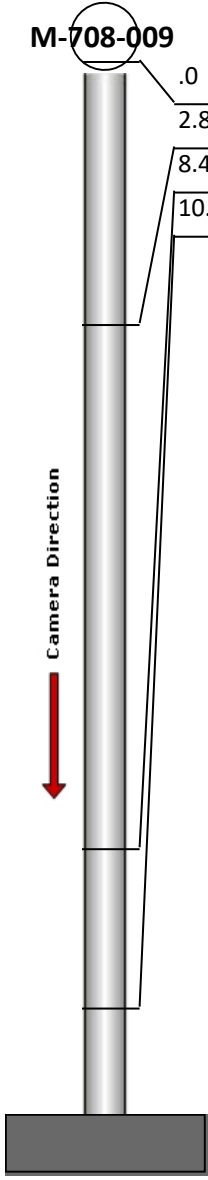
.0	MGP	General Photo	10	NA
	2.8	MGP	General Photo	29	NA
	8.4	DSF	Deposits Settled Fine	54	M 3
	10.1	MGO	General Observation	69	NA
