Manhole Inspection Report

Date:	04/20/2018	Weather:		Coding:	RZMACP
MH#:	M-708-022	Owner:	NA	Len. Surveyed:	5.9
P.O.#:		Surveyor:	John Kuglmaier	Rim to Invert:	8.0
Customer:		Cert. #:	U-1215-07002349	Wall Material:	Concrete (reinforced)

Street:	175' East of 14th St. and Hwy 51.	Project:	Hobart, IN
City:	Hobart, IN	GPS Northing:	0.0
Location:		GPS Easting:	0.0
Drain Area:	Southwest	GPS Accuracy:	Nearest Meter
Cover Shape:	Circular	Evidence of Surcharge:	No
Cover Size:	22.5	Potential for Runoff:	None
Comments:

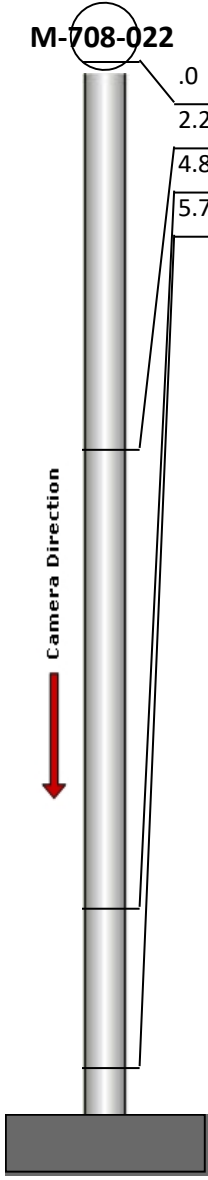
.0	MGP	General Photo	10	NA
	2.2	MGP	General Photo	28	NA
	4.8	DAZ	Deposits Attached Other	47	M 2
	5.7	MGO	General Observation	60	NA
