Manhole Inspection Report

Date:	04/22/2018	Weather:		Coding:	RZMACP
MH#:	M-708-024	Owner:	NA	Len. Surveyed:	9.8
P.O.#:		Surveyor:	John Kuglmaier	Rim to Invert:	10.7
Customer:	8.7	Cert. #:	U-1215-07002349	Wall Material:	Concrete (reinforced)

Street:	137' South of 14th St. and Hwy 51.	Project:	Hobart, IN
City:	Hobart, IN	GPS Northing:	0.0
Location:		GPS Easting:	0.0
Drain Area:	Southwest	GPS Accuracy:	Nearest Meter
Cover Shape:	Circular	Evidence of Surcharge:	Yes
Cover Size:	26.0	Potential for Runoff:	None
Comments:

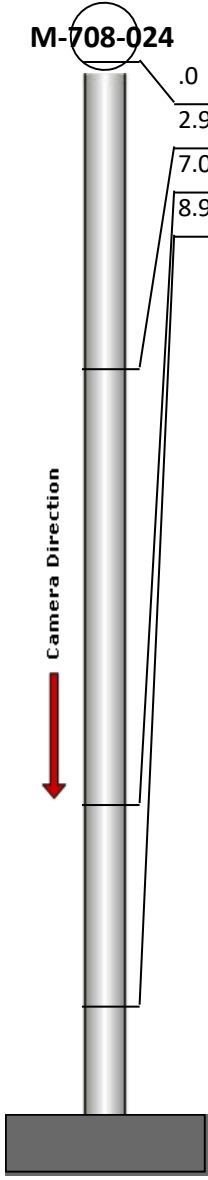
.0	MGP	General Photo	10	NA
	2.9	MGP	General Photo	30	NA
	7.0	DSF	Deposits Settled Fine	52	M 3
	8.9	MGO	General Observation	67	NA
