Manhole Inspection Report

Date:	04/20/2018	Weather:		Coding:	RZMACP
MH#:	M-708-026	Owner:	NA	Len. Surveyed:	1.9
P.O.#:		Surveyor:	Jen Costello	Rim to Invert:	6.2
Customer:		Cert. #:	U-907-5518	Wall Material:	Concrete (reinforced)

Street:	438' North of Bracken Pky. 92' East	Project:	Hobart, IN
City:	Hobart, IN	GPS Northing:	2904758.755
Location:		GPS Easting:	2904758.755
Drain Area:	Southwest	GPS Accuracy:	Sub-Meter
Cover Shape:	Circular	Evidence of Surcharge:	No
Cover Size:	22.5	Potential for Runoff:	None
Comments:

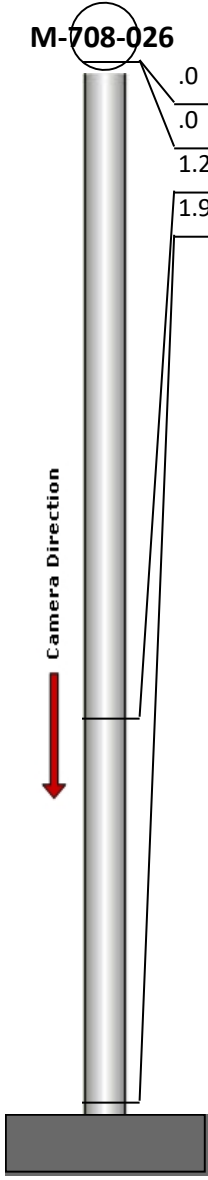
.0	MGO	General Observation	10	NA
	.0	SAP	Surface Aggregate Projecting	20	S 3
	1.2	OBP	Obstacle External Pipe or Cable	33	M 2
	1.9	MSA	Abandoned Survey	45	NA
