Manhole Inspection Report

Date:	04/20/2018	Weather:		Coding:	RZMACP
MH#:	M-708-027	Owner:	NA	Len. Surveyed:	1.9
P.O.#:		Surveyor:	John Kuglmaier	Rim to Invert:	5.9
Customer:		Cert. #:	U-1215-07002349	Wall Material:	Concrete (reinforced)

Street:	438' North of Bracken Pky. 87' East	Project:	Hobart, IN
City:	Hobart, IN	GPS Northing:	2904755.251
Location:		GPS Easting:	2904755.251
Drain Area:	Southwest	GPS Accuracy:	Sub-Meter
Cover Shape:	Circular	Evidence of Surcharge:	Yes
Cover Size:	22.5	Potential for Runoff:	None
Comments:

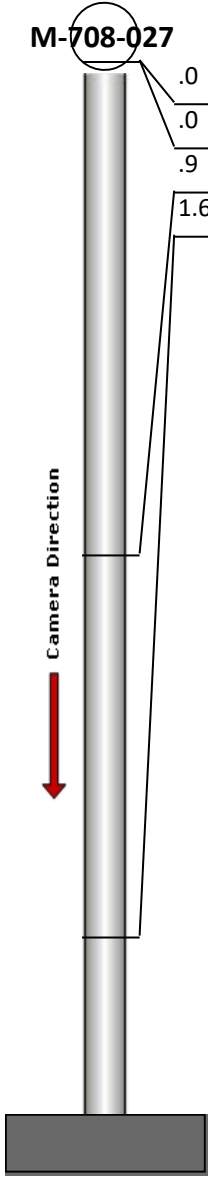
.0	MGP	General Photo	10	NA
	.0	FL	Fracture Longitudinal	22	S 3
	.9	MGO	General Observation	35	NA
	1.6	MSA	Abandoned Survey	48	NA
