Manhole Inspection Report

Date:	04/19/2018	Weather:		Coding:	RZMACP
MH#:	M-708-102	Owner:	NA	Len. Surveyed:	8.7
P.O.#:		Surveyor:	Jen Costello	Rim to Invert:	9.9
Customer:		Cert. #:	U-907-5518	Wall Material:	Concrete (reinforced)

Street:	Bracken Parkway. 313' East of Lake	Project:	Hobart, IN
City:	Hobart, IN	GPS Northing:	2904984.703
Location:		GPS Easting:	2904984.703
Drain Area:	Southwest	GPS Accuracy:	Sub-Meter
Cover Shape:	Circular	Evidence of Surcharge:	No
Cover Size:	22.5	Potential for Runoff:	None
Comments:

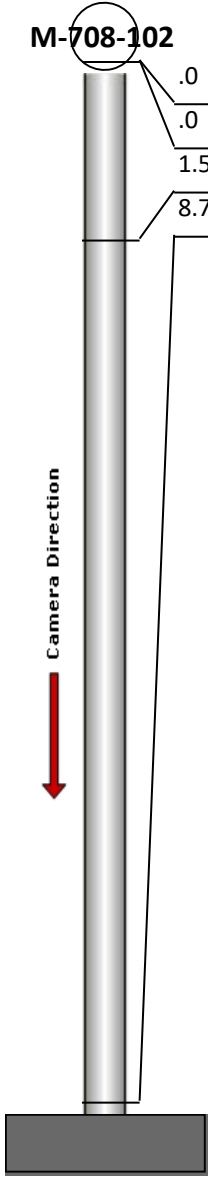
.0	MGO	General Observation	10	NA
	.0	SAV	Surface Aggregate Visible	20	S 3
	1.5	MGO	General Observation	36	NA
	8.7	MGO	General Observation	63	NA
