Manhole Inspection Report

| MH#: | M-708-104 | Owner: | NA | Len. Surveyed: | 8.7 |

| Street: | Bracken Parkway. 144' Northwest of | Project: | Hobart, IN |

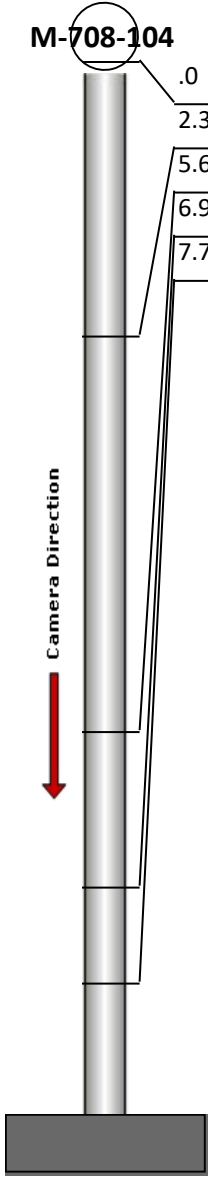
| | Position | Code | Observation | Video (sec) | Grade |
|--|---|---|---|---|---|
| | 5.6 | DSF | Deposits Settled Fine | 49 | M 2 |
| | 6.9 | IS | Infil Stain | 63 | NA |
