Manhole Inspection Report

Date:	04/10/2018	Weather:		Coding:	RZMACP
MH#:	M-708-114	Owner:	NA	Len. Surveyed:	6.3
P.O.#:		Surveyor:	John Kuglmaier	Rim to Invert:	7.0
Customer:		Cert. #:	U-1215-07002349	Wall Material:	Concrete (reinforced)

Street:	Bracken Pky. 148' North of Capitol D	Project:	Hobart, IN
City:	Hobart, IN	GPS Northing:	2906942.61
Location:		GPS Easting:	2906942.61
Drain Area:	Southwest	GPS Accuracy:	Sub-Meter
Cover Shape:	Circular	Evidence of Surcharge:	No
Cover Size:	22.5	Potential for Runoff:	None
Comments:

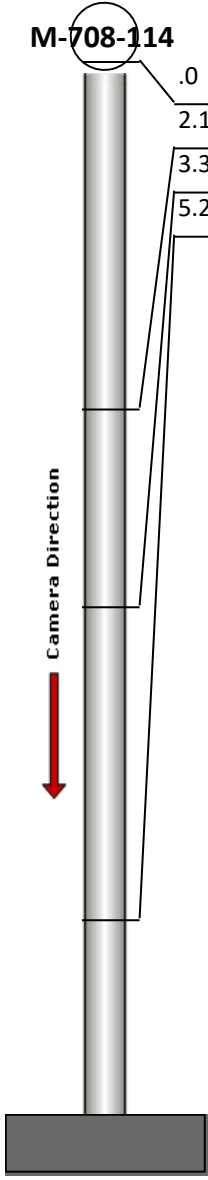
.0	MGP	General Photo	10	NA
	2.1	MGP	General Photo	28	NA
	3.3	DSF	Deposits Settled Fine	44	M 2
	5.2	MGO	General Observation	59	NA
