Manhole Inspection Report

Date:	04/10/2018	Weather:		Coding:	RZMACP
MH#:	M-708-123	Owner:	NA	Len. Surveyed:	6.6
P.O.#:		Surveyor:	John Kuglmaier	Rim to Invert:	7.9
Customer:		Cert. #:	U-1215-07002349	Wall Material:	Concrete (reinforced)

Street:	Intersection of Redbud Dr. and Tam	Project:	Hobart, IN
City:	Hobart, IN	GPS Northing:	2905154.198
Location:		GPS Easting:	2905154.198
Drain Area:	Southwest	GPS Accuracy:	Sub-Meter
Cover Shape:	Circular	Evidence of Surcharge:	No
Cover Size:	22.5	Potential for Runoff:	None
Comments:

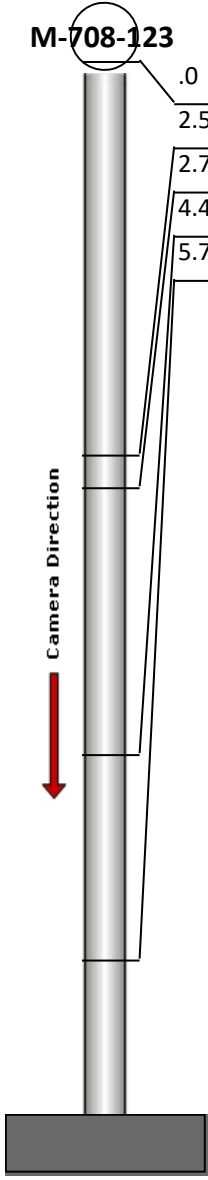
.0	MGP	General Photo	10	NA
	2.5	IS	Infil Stain	27	NA
	2.7	MGP	General Photo	41	NA
	4.4	DSF	Deposits Settled Fine	58	M 2
	5.7	MGO	General Observation	72	NA
