Manhole Inspection Report

Date:	04/10/2018	Weather:		Coding:	RZMACP
MH#:	M-708-124	Owner:	NA	Len. Surveyed:	5.2
P.O.#:		Surveyor:	John Kuglmaier	Rim to Invert:	6.2
Customer:		Cert. #:	U-1215-07002349	Wall Material:	Concrete (reinforced)

Street:	Redbud Dr. 72' North of Heather Ln.	Project:	Hobart, IN
City:	Hobart, IN	GPS Northing:	2905161.519
Location:		GPS Easting:	2905161.519
Drain Area:	Southwest	GPS Accuracy:	Sub-Meter
Cover Shape:	Circular	Evidence of Surcharge:	Yes
Cover Size:	22.5	Potential for Runoff:	None
Comments:

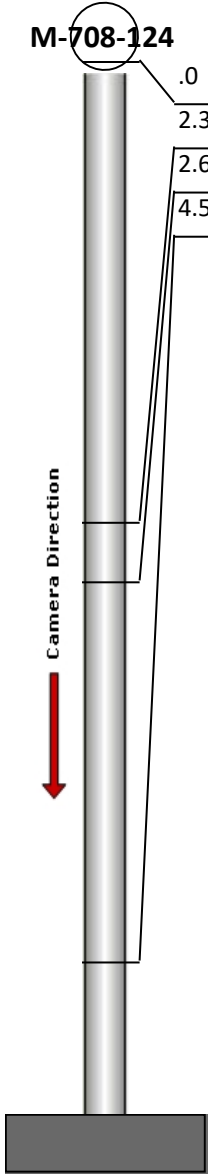
.0	MGP	General Photo	10	NA
	2.3	MGP	General Photo	28	NA
	2.6	DSF	Deposits Settled Fine	43	M 2
	4.5	MGO	General Observation	58	NA
