Manhole Inspection Report

Date:	04/10/2018	Weather:		Coding:	RZMACP
MH#:	M-708-126	Owner:	NA	Len. Surveyed:	5.0
P.O.#:		Surveyor:	John Kuglmaier	Rim to Invert:	5.8
Customer:		Cert. #:	U-1215-07002349	Wall Material:	Concrete (reinforced)

Street:	Redbud Dr. 150' South of Heather Ln	Project:	Hobart, IN
City:	Hobart, IN	GPS Northing:	2905253.934
Location:		GPS Easting:	2905253.934
Drain Area:	Southwest	GPS Accuracy:	Sub-Meter
Cover Shape:	Circular	Evidence of Surcharge:	Yes
Cover Size:	22.5	Potential for Runoff:	None
Comments:

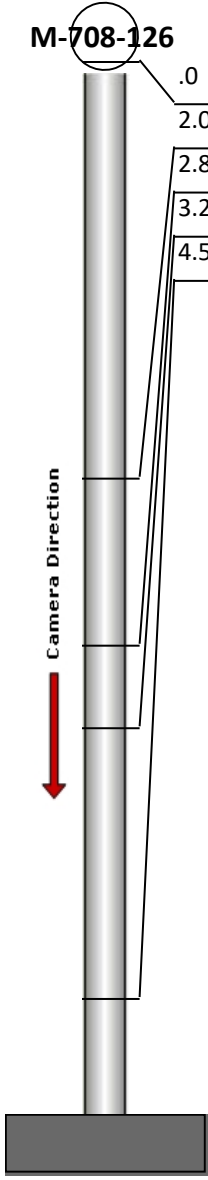
.0	MGP	General Photo	10	NA
	2.0	MGP	General Photo	28	NA
	2.8	DSF	Deposits Settled Fine	43	M 2
	3.2	IS	Infil Stain	56	NA
	4.5	MGO	General Observation	70	NA
