Manhole Inspection Report

| MH#: | M-708-127 | Owner: | NA | Len. Surveyed: | 4.6 |

| Street: | Redbud Dr. 234' South of Heather Ln | Project: | Missing GPS |
| City: | Hobart, IN | GPS Northing: | 2280330.026 |

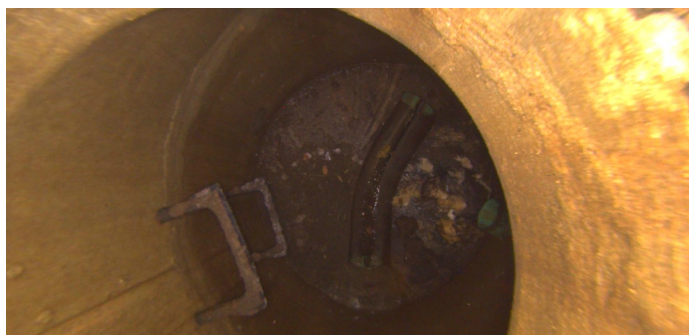
Code: **MGO**
Description: **General Observation**

Distance (ft): **.0**
Structural Grade: **0**
O&M Grade: **0**
Clock Start/From:
Clock To:
1st Value:
2nd Value:
Value Percent:
Step: **NO**
Remarks: **access mh**

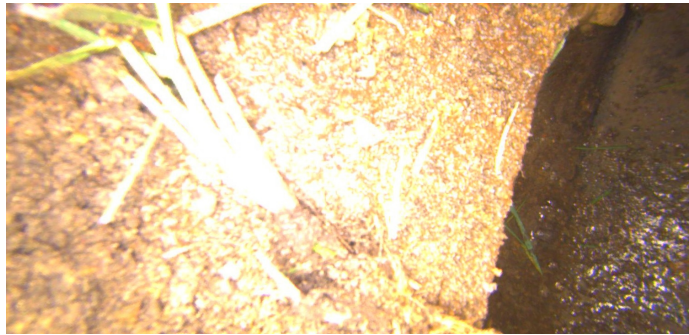
Code: **MGO**
Description: **General Observation**

Distance (ft): **4.6**
Structural Grade: **0**
O&M Grade: **0**
Clock Start/From:
Clock To:
1st Value:
2nd Value:
Value Percent:
Step: **NO**
Remarks: **end of survey**
