Manhole Inspection Report

Date:	04/10/2018	Weather:		Coding:	RZMACP
MH#:	M-708-133	Owner:	NA	Len. Surveyed:	6.4
P.O.#:		Surveyor:	John Kuglmaier	Rim to Invert:	6.9
Customer:		Cert. #:	U-1215-07002349	Wall Material:	Concrete (reinforced)

Street:	Magnolia Dr. 151' Southeast of Heat	Project:	Hobart, IN
City:	Hobart, IN	GPS Northing:	2905920.983
Location:		GPS Easting:	2905920.983
Drain Area:	Southwest	GPS Accuracy:	Sub-Meter
Cover Shape:	Circular	Evidence of Surcharge:	No
Cover Size:	22.5	Potential for Runoff:	None
Comments:

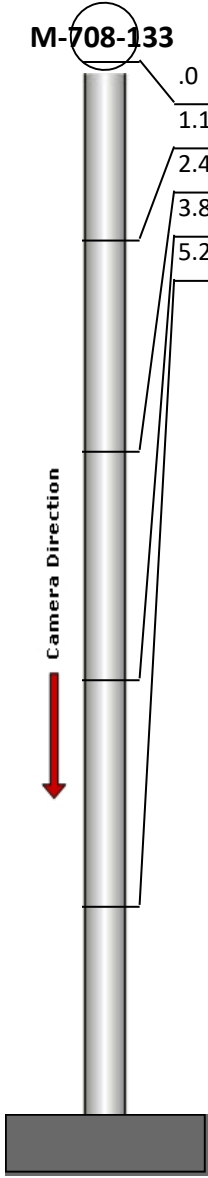
.0	MGP	General Photo	10	NA
	1.1	IS	Infil Stain	24	NA
	2.4	MGP	General Photo	40	NA
	3.8	DAZ	Deposits Attached Other	57	M 2
	5.2	MGO	General Observation	71	NA
