Manhole Inspection Report

Date:	04/10/2018	Weather:		Coding:	RZMACP
MH#:	M-708-138	Owner:	NA	Len. Surveyed:	5.6
P.O.#:		Surveyor:	John Kuglmaier	Rim to Invert:	6.5
Customer:		Cert. #:	U-1215-07002349	Wall Material:	Concrete (reinforced)

Street:	Heather Ln. 288' West of Magnolia	Project:	Hobart, IN
City:	Hobart, IN	GPS Northing:	2905543.41
Location:		GPS Easting:	2905543.41
Drain Area:	Southwest	GPS Accuracy:	Sub-Meter
Cover Shape:	Circular	Evidence of Surcharge:	No
Cover Size:	22.5	Potential for Runoff:	None
Comments:

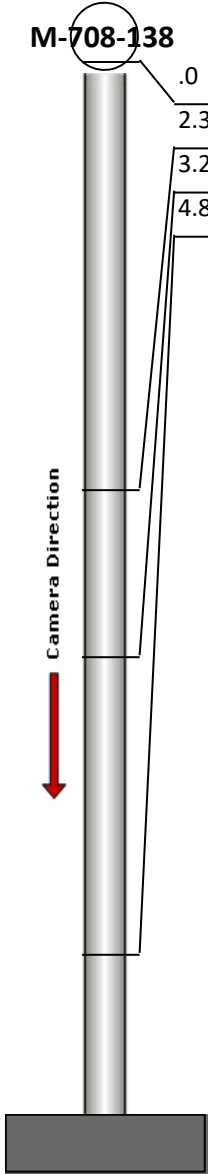
.0	MGP	General Photo	10	NA
	2.3	MGP	General Photo	29	NA
	3.2	DSF	Deposits Settled Fine	44	M 2
	4.8	MGO	General Observation	59	NA
