Manhole Inspection Report

Date:	04/19/2018	Weather:		Coding:	RZMACP
MH#:	M-708-150	Owner:	NA	Len. Surveyed:	4.1
P.O.#:		Surveyor:	John Kuglmaier	Rim to Invert:	4.6
Customer:		Cert. #:	U-1215-07002349	Wall Material:	Concrete (reinforced)

Street:	West of Lake St. North of Coral Cove	Project:	Hobart, IN
City:	Hobart, IN	GPS Northing:	2905498.96
Location:		GPS Easting:	2905498.96
Drain Area:	Southwest	GPS Accuracy:	Sub-Meter
Cover Shape:	Circular	Evidence of Surcharge:	No
Cover Size:	22.5	Potential for Runoff:	None
Comments:

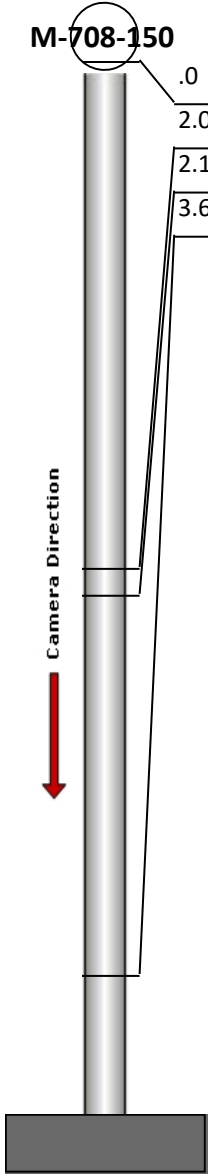
Position	Code	Observation	Video (sec)	Grade

.0	MGP	General Photo	10	NA
	2.0	DSF	Deposits Settled Fine	26	M 2
	2.1	MGP	General Photo	40	NA
	3.6	MGO	General Observation	56	NA
