Manhole Inspection Report

Date:	04/10/2018	Weather:		Coding:	RZMACP
MH#:	M-708-166	Owner:	NA	Len. Surveyed:	3.7
P.O.#:		Surveyor:	John Kuglmaier	Rim to Invert:	4.4
Customer:		Cert. #:	U-1215-07002349	Wall Material:	Concrete (reinforced)

Street:	Lincoln St. and Capitol Dr. to the Nor	Project:	Hobart, IN
City:	Hobart, IN	GPS Northing:	2906518.446
Location:		GPS Easting:	2906518.446
Drain Area:	Southwest	GPS Accuracy:	Sub-Meter
Cover Shape:	Circular	Evidence of Surcharge:	No
Cover Size:	22.5	Potential for Runoff:	None
Comments:

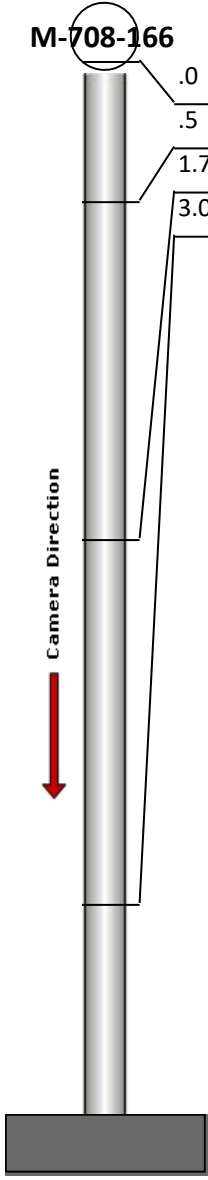
.0	MGP	General Photo	10	NA
	.5	DAZ	Deposits Attached Other	23	M 2
	1.7	MGP	General Photo	39	NA
	3.0	MGO	General Observation	55	NA
