Manhole Inspection Report

Date:	04/12/2018	Weather:		Coding:	RZMACP
MH#:	M-709-012	Owner:	NA	Len. Surveyed:	12.4
P.O.#:		Surveyor:	John Kuglmaier	Rim to Invert:	12.7
Customer:		Cert. #:	U-1215-07002349	Wall Material:	Concrete (reinforced)

Street:	Avocet Circle. Dunlin Circle.	Project:	Hobart, IN
City:	Hobart, IN	GPS Northing:	2906768.201
Location:		GPS Easting:	2906768.201
Drain Area:	Southwest	GPS Accuracy:	Sub-Meter
Cover Shape:	Circular	Evidence of Surcharge:	Yes
Cover Size:	22.5	Potential for Runoff:	None
Comments:

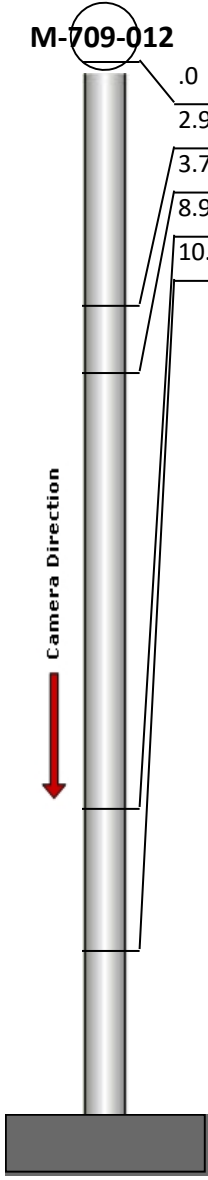
.0	MGP	General Photo	10	NA
	2.9	MGP	General Photo	30	NA
	3.7	IS	Infil Stain	45	NA
	8.9	DAZ	Deposits Attached Other	67	M 2
	10.6	MGO	General Observation	82	NA
