Manhole Inspection Report

Date:	04/11/2018	Weather:		Coding:	RZMACP
MH#:	M-709-021	Owner:	NA	Len. Surveyed:	6.3
P.O.#:		Surveyor:	John Kuglmaier	Rim to Invert:	6.9
Customer:		Cert. #:	U-1215-07002349	Wall Material:	Concrete (reinforced)

Street:	Avocet Circle. Northwest Corner.	Project:	Hobart, IN
City:	Hobart, IN	GPS Northing:	2906144.472
Location:		GPS Easting:	2906144.472
Drain Area:	Southwest	GPS Accuracy:	Sub-Meter
Cover Shape:	Circular	Evidence of Surcharge:	No
Cover Size:	22.5	Potential for Runoff:	None
Comments:

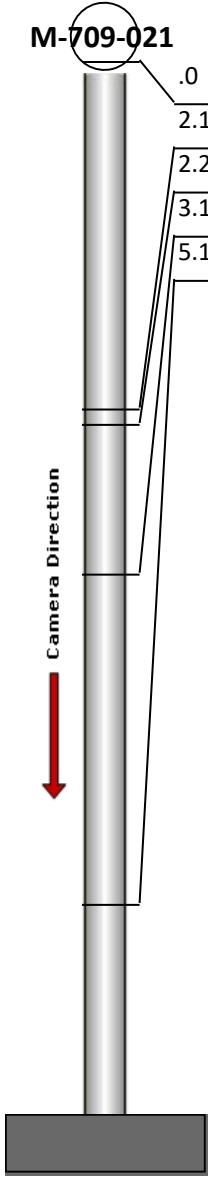
.0	MGP	General Photo	10	NA
	2.1	IS	Infil Stain	26	NA
	2.2	MGP	General Photo	40	NA
	3.1	DAZ	Deposits Attached Other	55	M 2
	5.1	MGO	General Observation	71	NA
