Manhole Inspection Report

Date:	11/01/2022	Weather:		Coding:	RZMACP
MH#:	M-709-033	Owner:	NA	Len. Surveyed:	5.7
P.O.#:		Surveyor:	Jen Costello	Rim to Invert:	6.7
Customer:		Cert. #:	U-907-5518	Wall Material:	Concrete (non-reinforced)

Street:	Waxwing Circle. Southwest Corner.	Project:	Missing GPS
City:	Hobart, IN	GPS Northing:	2278620.77
Location:		GPS Easting:	2906445.071
Drain Area:	Southwest	GPS Accuracy:	Sub-Meter
Cover Shape:	Circular	Evidence of Surcharge:	No
Cover Size:	24.0	Potential for Runoff:	None
Comments:

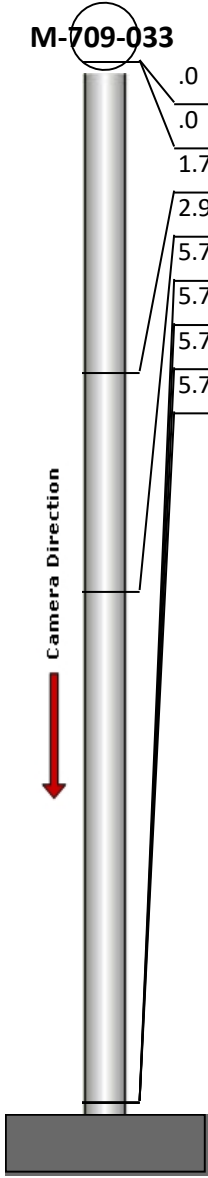
Position	Code	Observation	Video (sec)	Grade

.0	MGO	General Observation	10	NA
	.0	SRI	Surface Roughness Increased	21	S 1
	1.7	MGO	General Observation	38	NA
	2.9	FL	Fracture Longitudinal	54	S 3
	5.7	SAV	Surface Aggregate Visible	72	S 3
	5.7	DSF	Deposits Settled Fine	83	M 2
	5.7	SRI	Surface Roughness Increased	95	S 1
	5.7	MGO	General Observation	106	NA
