Manhole Inspection Report

Date:	03/22/2018	Weather:		Coding:	RZMACP
MH#:	M-802-001	Owner:	NA	Len. Surveyed:	4.3
P.O.#:		Surveyor:	John Kuglmaier	Rim to Invert:	5.5
Customer:		Cert. #:	U-1215-07002349	Wall Material:	Concrete (reinforced)

Street:	197' North of Hwy 6. and West of H	Project:	Hobart, IN
City:	Hobart, IN	GPS Northing:	0.0
Location:		GPS Easting:	0.0
Drain Area:	Northeast	GPS Accuracy:	Nearest Meter
Cover Shape:	Circular	Evidence of Surcharge:	Yes
Cover Size:	23.0	Potential for Runoff:	None
Comments:

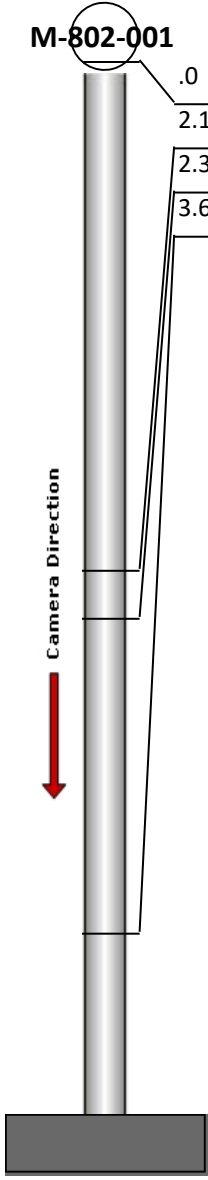
.0	MGP	General Photo	10	NA
	2.1	MGO	General Observation	26	NA
	2.3	MGP	General Photo	40	NA
	3.6	MGO	General Observation	56	NA
