Manhole Inspection Report

Date:	03/22/2018	Weather:		Coding:	RZMACP
MH#:	M-802-008	Owner:	NA	Len. Surveyed:	9.1
P.O.#:		Surveyor:	John Kuglmaier	Rim to Invert:	10.0
Customer:		Cert. #:	U-1215-07002349	Wall Material:	Concrete (reinforced)

Street:	South of 34th Ln. 271' West of Hwy	Project:	Hobart, IN
City:	Hobart, IN	GPS Northing:	0.0
Location:		GPS Easting:	0.0
Drain Area:	Northeast	GPS Accuracy:	Nearest Meter
Cover Shape:	Circular	Evidence of Surcharge:	Yes
Cover Size:	23.0	Potential for Runoff:	None
Comments:

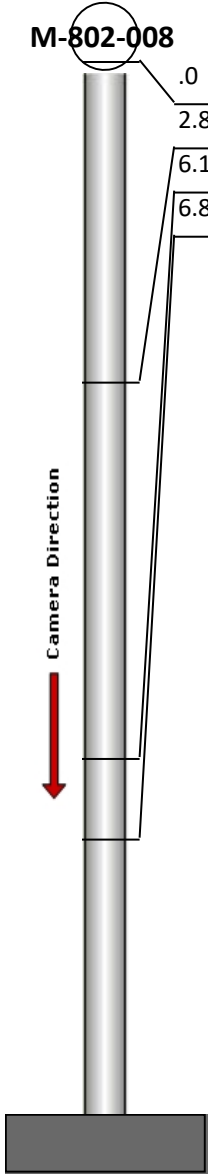
.0	MGP	General Photo	10	NA
	2.8	MGP	General Photo	30	NA
	6.1	DAZ	Deposits Attached Other	50	M 2
	6.8	MGO	General Observation	63	NA
