Manhole Inspection Report

| MH#: | M-802-018 | Owner: | NA | Len. Surveyed: | 4.2 |

| Street: | 290' West of North Ridge Dr. North | Project: | Hobart, IN |

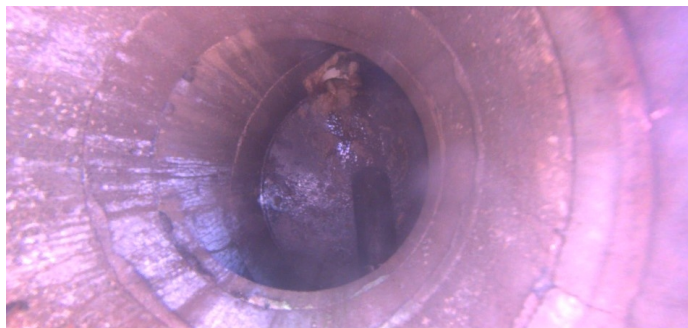
Code: **MGP**
Description: **General Photo**

Distance (ft): **.0**
Structural Grade: **0**
O&M Grade: **0**
Clock Start/From:
Clock To:
1st Value:
2nd Value:
Value Percent:
Step: **NO**
Remarks:

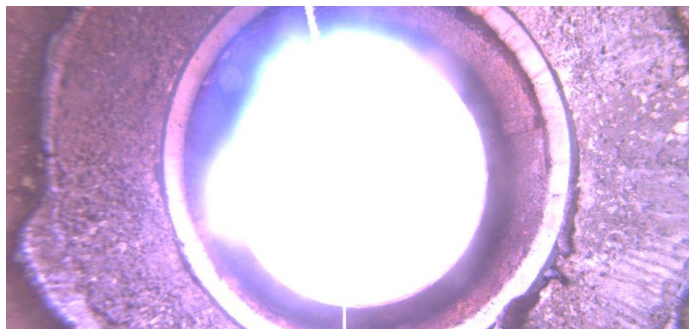
Code: **MGP**
Description: **General Photo**

Distance (ft): **2.3**
Structural Grade: **0**
O&M Grade: **0**
Clock Start/From:
Clock To:
1st Value:
2nd Value:
Value Percent:
Step: **NO**
Remarks:

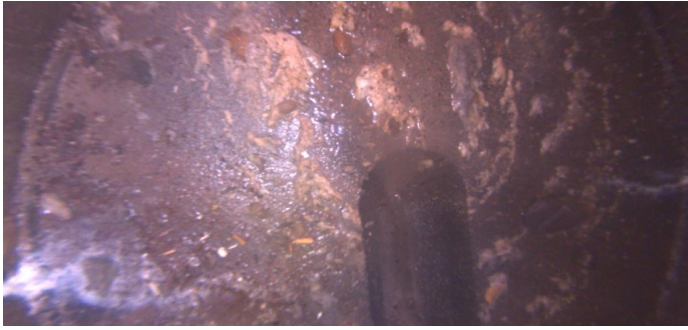
| Code: | MGO |
| Description: | General Observation |
