Manhole Inspection Report

Date:	03/21/2018	Weather:		Coding:	RZMACP
MH#:	M-802-024	Owner:	NA	Len. Surveyed:	2.1
P.O.#:		Surveyor:	John Kuglmaier	Rim to Invert:	3.0
Customer:		Cert. #:	U-1215-07002349	Wall Material:	Concrete (reinforced)

Street:	177' North of Hwy 6. 97' West of No	Project:	Hobart, IN
City:	Hobart, IN	GPS Northing:	0.0
Location:		GPS Easting:	0.0
Drain Area:	Northeast	GPS Accuracy:	Nearest Meter
Cover Shape:	Circular	Evidence of Surcharge:	No
Cover Size:	23.0	Potential for Runoff:	None
Comments:

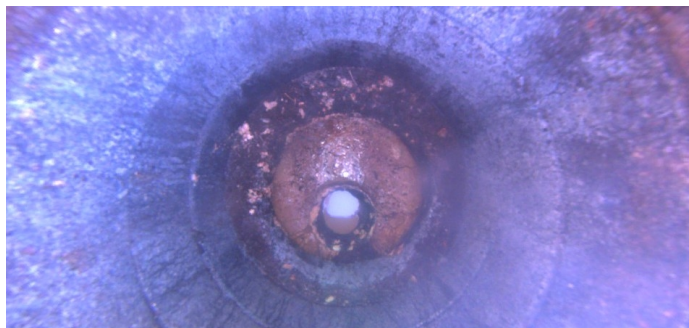
Code: **MGP**
Description: **General Photo**

Distance (ft): **.0**
Structural Grade: **0**
O&M Grade: **0**
Clock Start/From:
Clock To:
1st Value:
2nd Value:
Value Percent:
Step: **NO**
Remarks:
