Manhole Inspection Report

Date:	03/28/2018	Weather:		Coding:	RZMACP
MH#:	M-803-003	Owner:	NA	Len. Surveyed:	13.3
P.O.#:		Surveyor:	John Kuglmaier	Rim to Invert:	14.7
Customer:		Cert. #:	U-1215-07002349	Wall Material:	Concrete (reinforced)

Street:	164' South of North St. 163' West of	Project:	Hobart, IN
City:	Hobart, IN	GPS Northing:	0.0
Location:		GPS Easting:	0.0
Drain Area:	Northeast	GPS Accuracy:	Nearest Meter
Cover Shape:	Circular	Evidence of Surcharge:	Yes
Cover Size:	23.0	Potential for Runoff:	None
Comments:

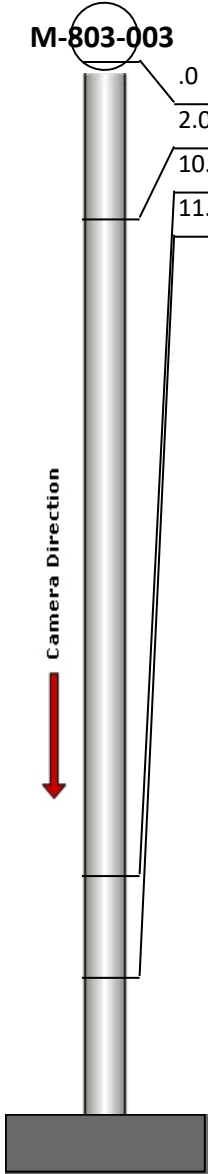
.0	MGP	General Photo	10	NA
	2.0	MGP	General Photo	28	NA
	10.4	DSF	Deposits Settled Fine	58	M 2
	11.7	MGO	General Observation	73	NA
