Manhole Inspection Report

Date:	03/28/2018	Weather:		Coding:	RZMACP
MH#:	M-803-009	Owner:	NA	Len. Surveyed:	13.4
P.O.#:		Surveyor:	John Kuglmaier	Rim to Invert:	14.9
Customer:		Cert. #:	U-1215-07002349	Wall Material:	Concrete (reinforced)

Street:	434' North of North St. 164' East of L	Project:	Hobart, IN
City:	Hobart, IN	GPS Northing:	0.0
Location:		GPS Easting:	0.0
Drain Area:	Northeast	GPS Accuracy:	Nearest Meter
Cover Shape:	Circular	Evidence of Surcharge:	Yes
Cover Size:	23.0	Potential for Runoff:	None
Comments:

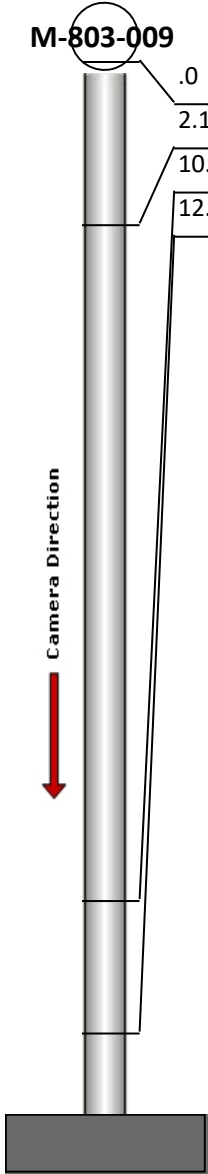
.0	MGP	General Photo	10	NA
	2.1	MGP	General Photo	28	NA
	10.8	DSF	Deposits Settled Fine	59	M 2
	12.5	MGO	General Observation	74	NA
