Manhole Inspection Report

Date:	04/12/2018	Weather:		Coding:	RZMACP
MH#:	M-803-013	Owner:	NA	Len. Surveyed:	9.8
P.O.#:		Surveyor:	John Kuglmaier	Rim to Invert:	11.9
Customer:		Cert. #:	U-1215-07002349	Wall Material:	Concrete (reinforced)

Street:	Wisconsin St. 29' North of 40th Plac	Project:	Hobart, IN
City:	Hobart, IN	GPS Northing:	2909718.837
Location:		GPS Easting:	2909718.837
Drain Area:	Northwest	GPS Accuracy:	Sub-Meter
Cover Shape:	Circular	Evidence of Surcharge:	Yes
Cover Size:	23.0	Potential for Runoff:	None
Comments:

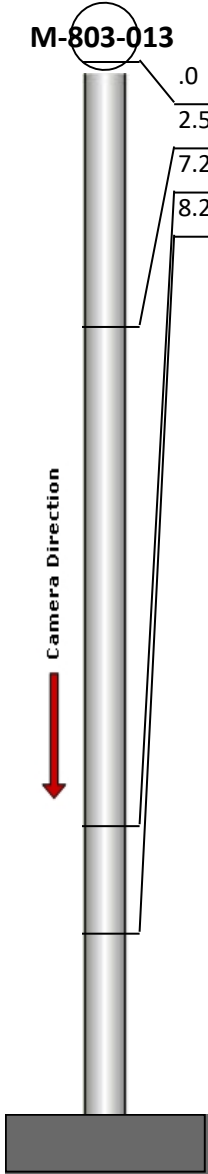
M-803-013				
	.0	MGP	General Photo	10	NA
	2.5	MGP	General Photo	29	NA
	7.2	DSF	Deposits Settled Fine	52	M 2
	8.2	MGO	General Observation	65	NA
